Southern Company Generation

Station Service Transformer Fire

March 7, 2017

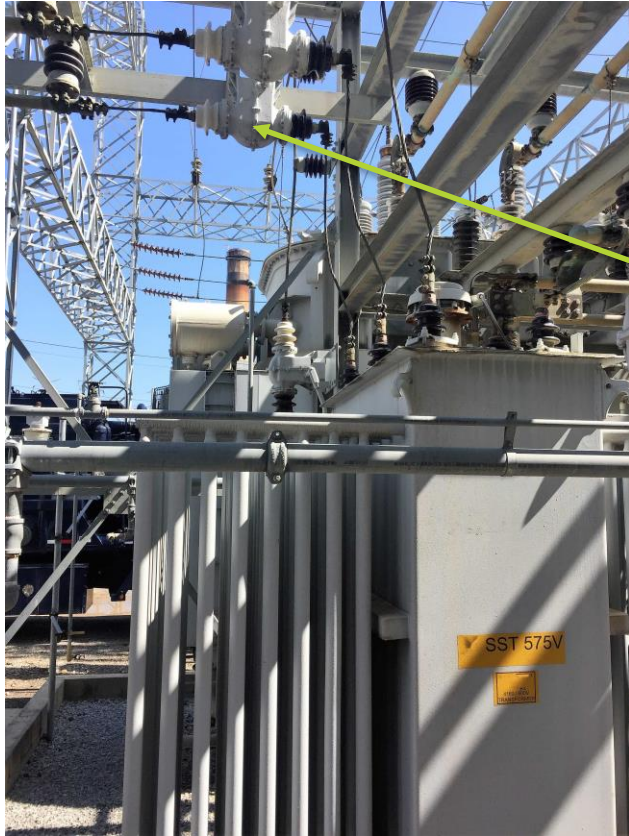
Current transformer above
SST on adjacent Unit

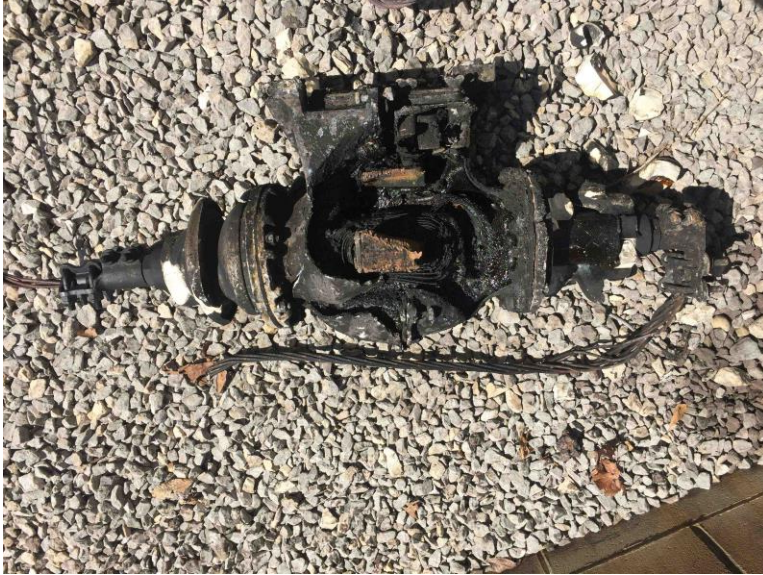
- 2152 hours – current transformer (CT) above 575v station service transformer (SST) fails, burning through the feet that mount the CT to the structure
- CT falls into the 575v SST bushings below
- Cracked bushing allows it to track to ground and fault the SST
- From video, arcing was active for about 40 seconds
- Visible fireball after about 40 seconds of arcing
- Plant does not have a Structural Fire Brigade

Failed current transformer (CT)

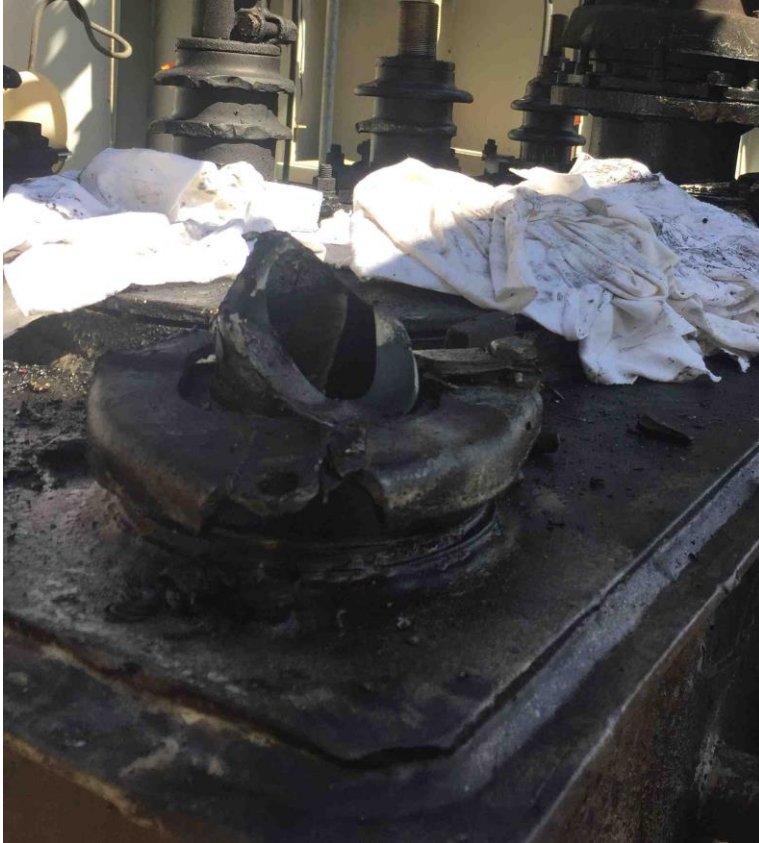
Bushing on top of SST

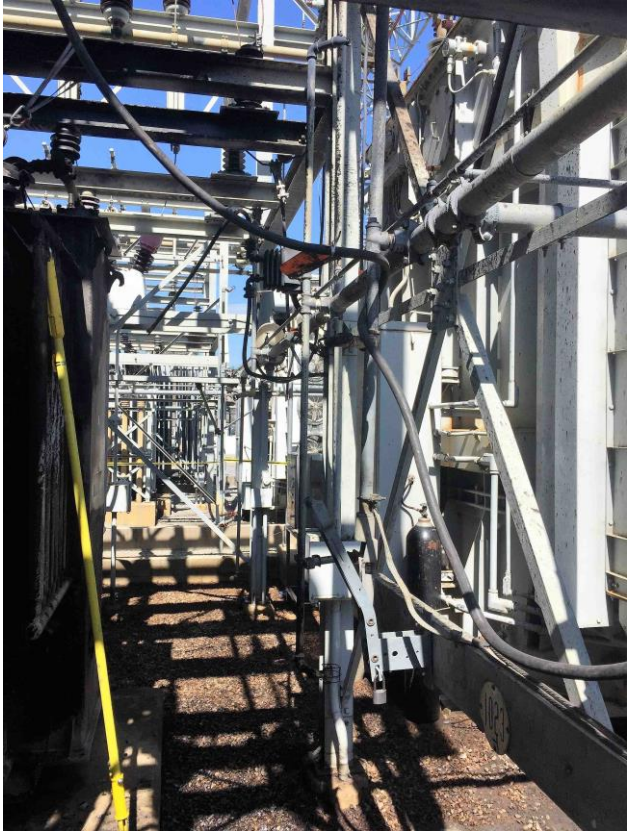
Roughly 8' separates SST and
GSU

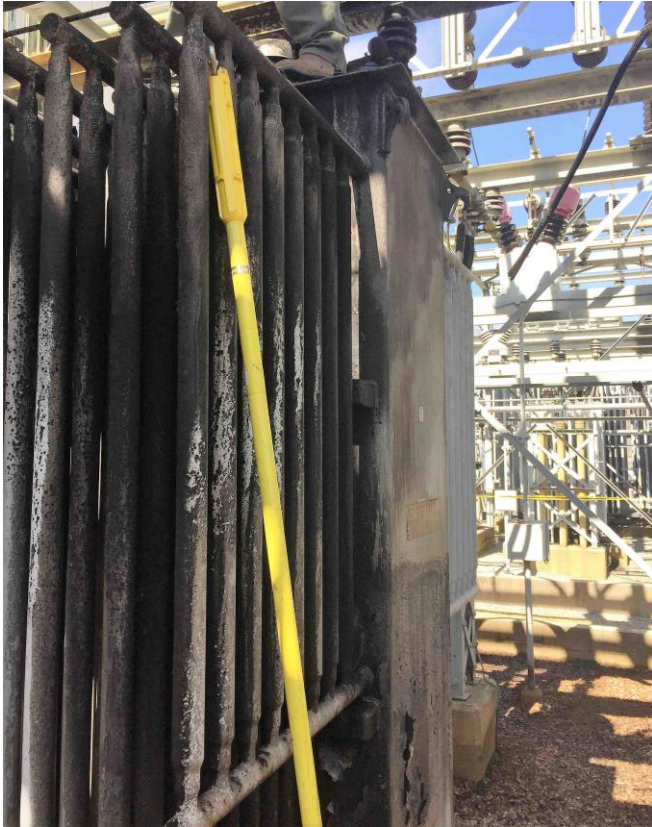
Damage to SST

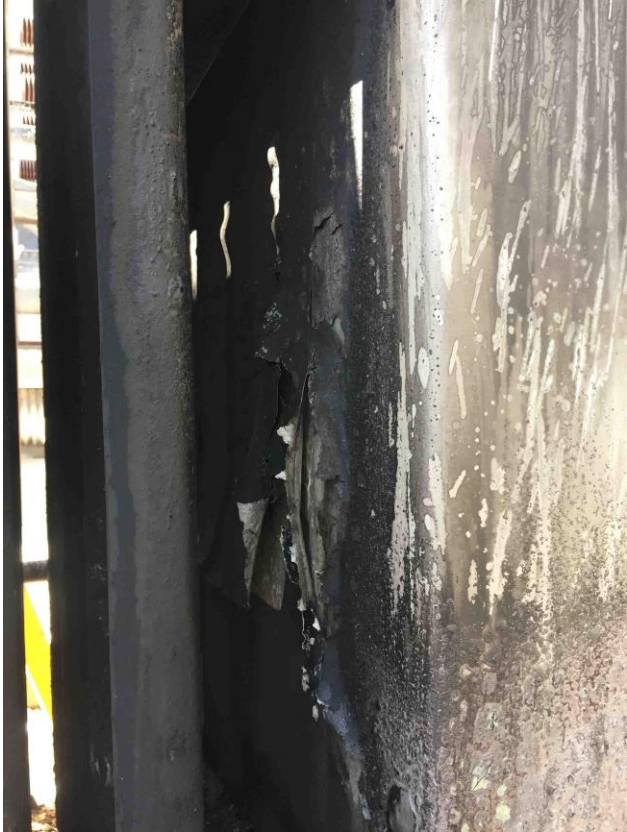
Damage to SST

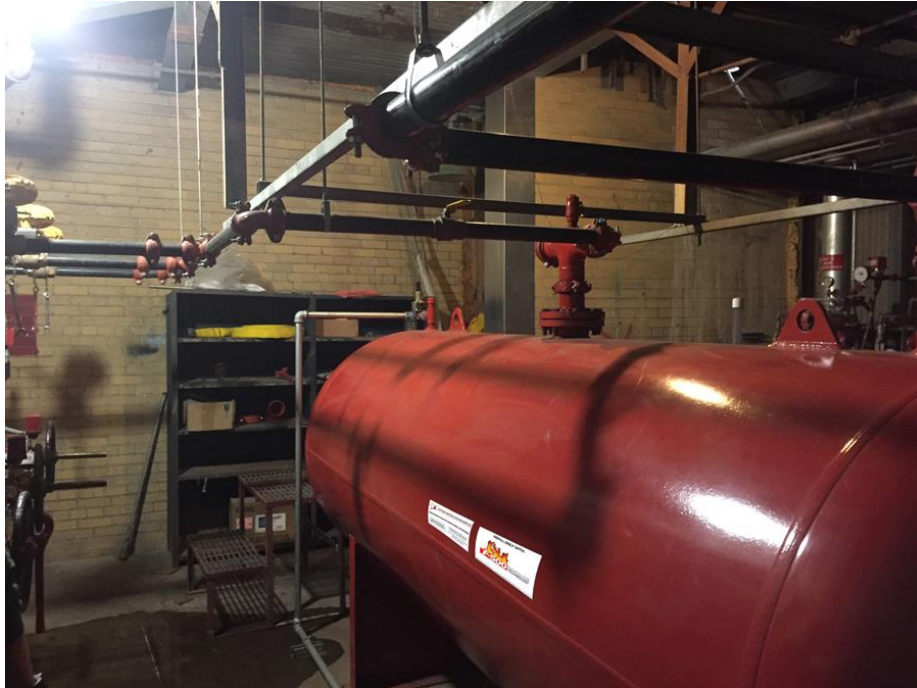
900 Gallon F-500 Encapsulator Agent Concentrate Bladder Tank

F-500 EA is proportioned into the water @ 3% for Class B 3D Fires

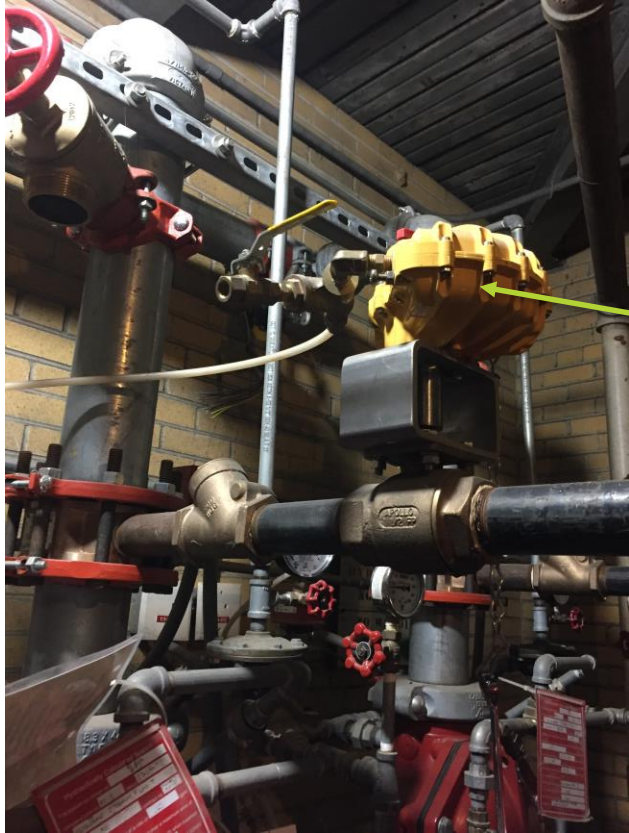
Automatic valve opens upon activation of sprinkler system, pulling product into riser
