# Queens Transformer Fire Prompts Use of New Technologies

## Foam Operations at Queens Box 33-6334

# F-500 and its Use at Queens Box 33-6334

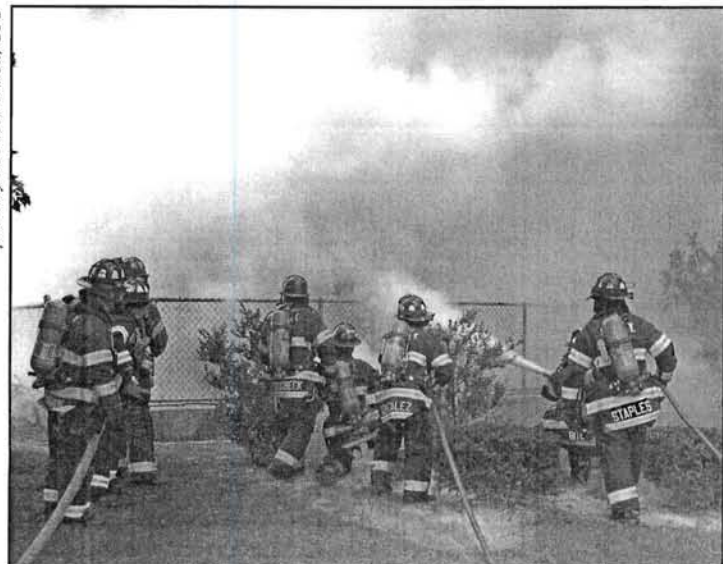
Engine companies protect exposures with hose-lines, preventing the fire from extending beyond the transformer.

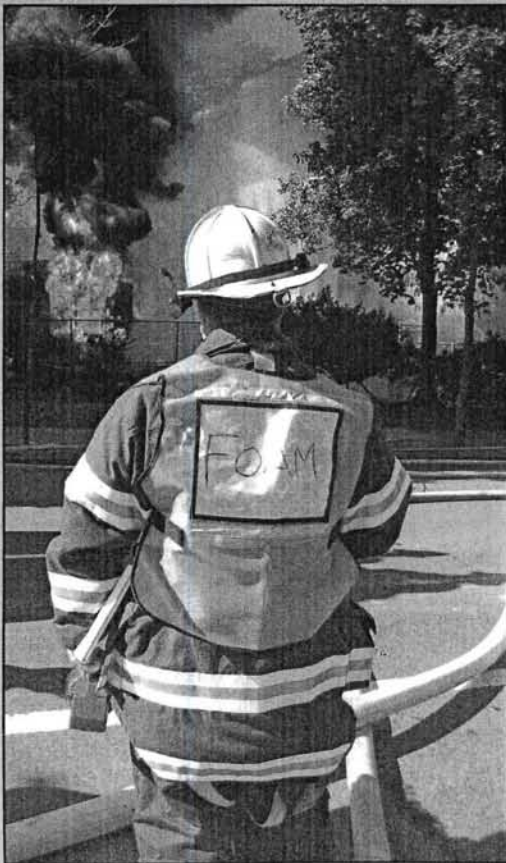
One of the two Foam Coordinators, who supervised operations at this incident.
