# Queens Transformer Fire Prompts Use of New Technologies

## Foam Operations at Queens Box 33-6334

# F-500 and its Use at Queens Box 33-6334

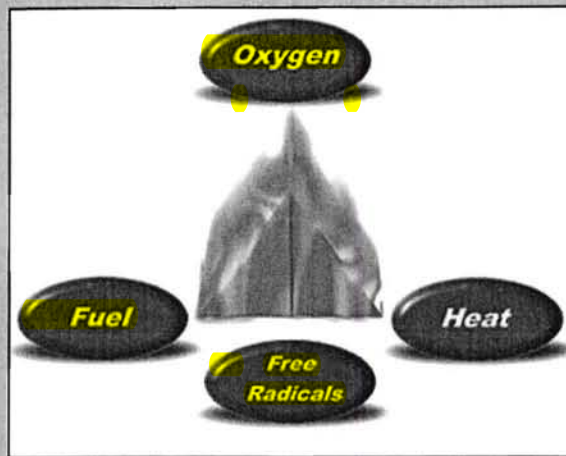
The burning material and surrounding non-combustible materials are cooled below the auto-ignition temperature of the burning material. F-500 acts on individual legs of the fire tetrahedron (see graphic at left) simultaneously. Foam separates the fuel from oxygen by forming a foam blanket. Foam is ineffective on flowing fuel and multi-dimensional fires.

When applied at the proper ratio, F-500 separates the fuel and oxygen by encapsulating the fuel in a chemical cocoon at the molecular level. The encapsulated fuel is neutralized and will not re-ignite even if disturbed. When F-500 was applied at this transformer fire, the fuel and transformer unit and internal oil were cooled. The flowing oil was cooled and neutralized; subsequently, the fire was quickly brought under control.
